Device TC1797
Marking/Step QS-AC
Package P/PG-BGA-416-10

01961AERRA

This Errata Sheet describes the deviations from the current user documentation.

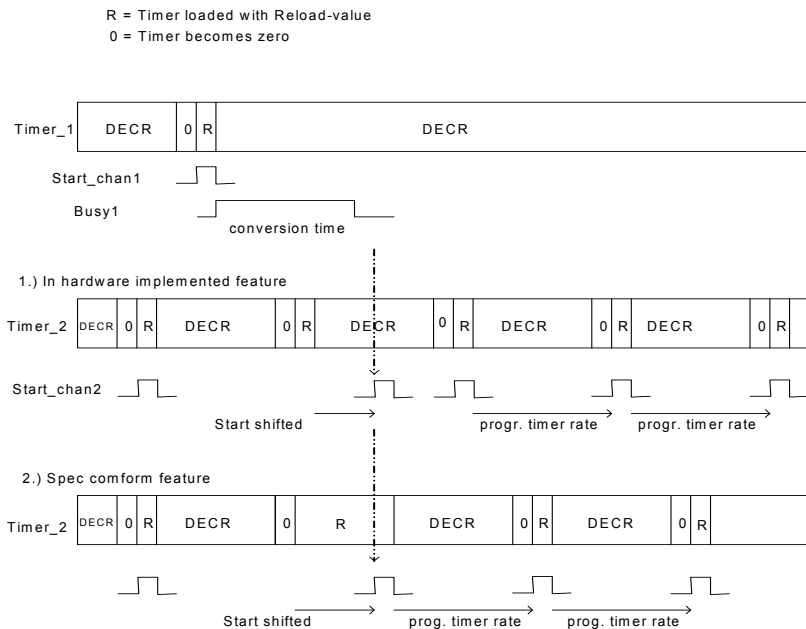
Figure 1 Timing concerning equidistant multiple timers

The correct behavior would be a reload when the requested conversion (of channel_2) is started.

Therefore the start of conversion for channel_2 is delayed by maximum one conversion-time. After this delay it will be continued with equidistant conversion-starts. Please refer to the following figure.

Note: the programmed timer rate is much longer than the conversion time, this means that the fault is much smaller than in the picture

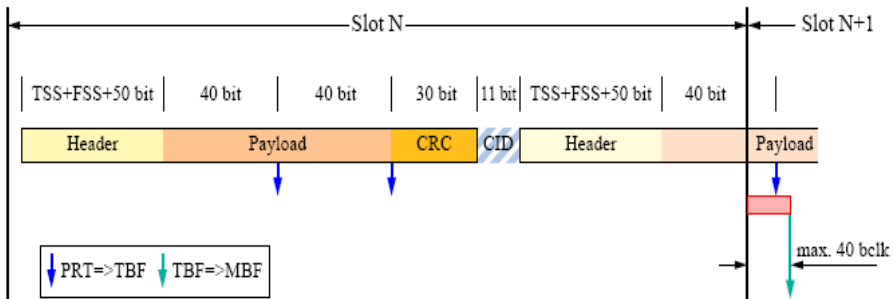
Figure 2 The second frame starts in the same slot

The erratum is limited to cases where the complete header and a part of the payload of another frame is received in slot N.

The transfer of a received valid frame from TBF to MBF is initiated by the end of the actual slot. Execution is started not later than 40 bclk periods after the slot change. 40 bclk periods equate 10 bit times, when $\text{bclk}=40\text{MHz}$. Corruption of payload occurs when a transfer from PRT to TBF happens in the red marked time window between start of new slot and start of transfer from TBF to MBF.

1. Ensure that the static slot length is configured suited to the static payload length.
2. Check Message Buffer Status for boundary violation.
