Active T89C51AC2, AT89C51AC2 Errata List

80C51 MCUs

AT89C51AC2
T89C51AC2

Errata Sheet

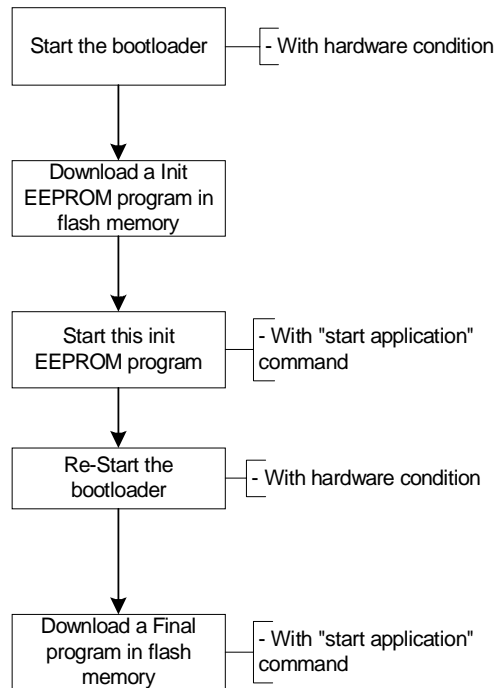
13. EEPROM – Lock-up during ISP write.

Program lock-up can be experienced when using Atmel FLIP software or a custom In system Programming tools to write in the internal EEPROM. This problem occurs with clock frequency > 12MHz in X2 mode or 24MHz in X1 mode. Neither the code Flash nor the EEPROM are corrupted by the lock-up. Although the EEPROM cannot be written by the bootloader.

This problem is bootloader related and doesn't affect the capability for the user to read and write into the EEPROM. This problem is technology dependant. The likelihood of experiencing the problem is low at Clock frequency > 24 MHz in X1 mode and null below. A reset can be applied to recover from the lock-up.

The following process can be done to work around the problem.

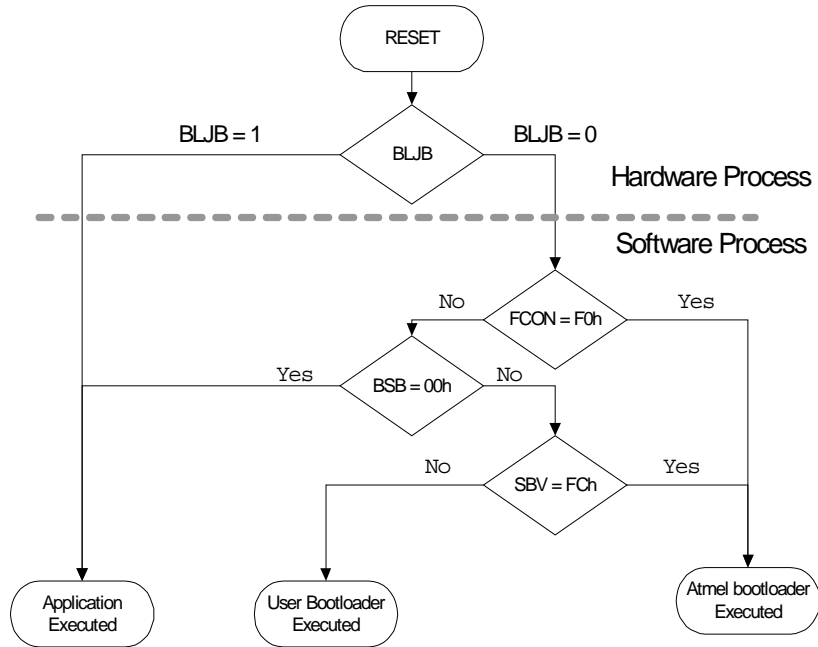
Version 1.2:

4. Boot Process Compatibility

There are some differences between Boot process of bootloader 1.2 and newer versions.

Use the fuse bit BLJB to start the application on both versions.
