# *NS9210/NS9215 Errata*

Part number/version: 90002007\_C

Release date: November 2010

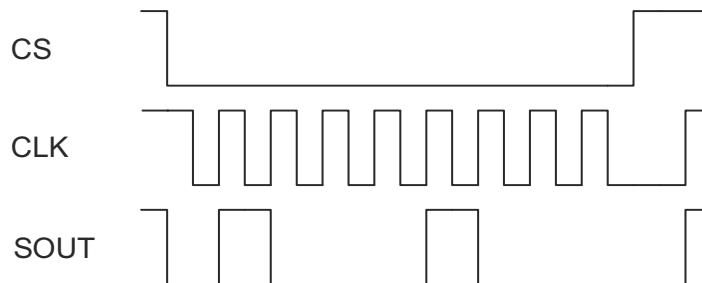
**SPI Mode 1**

In SPI modes 1, 2, and 3 an unexpected additional clock is inserted after the last byte is transmitted. See timing diagrams below. A portion of the unexpected clock cycle occurs while CS is asserted. Unless the SPI device connected to the NS9210/NS9215 port is capable of handling this unexpected behavior, this may cause SPI communication issues.

- Select SPI Mode 0 instead and enable the inversion function using the INV bit (D01) in the corresponding GPIO Configuration Register of SPI CLK. This workaround will also be integrated as an option in a future version of the NET+OS SPI driver API.
- FIM-based SPI port with support for SPI Mode 1.
